LANDSLIDES AND RELATED FEATURES

OF THE BURNSIDE, KY, QUADRANGLE

by
Alfred R. Taylor and Roger E. Thomas

U.S. Geological Survey
OPEN FILE MAP 82-653 (H-12)

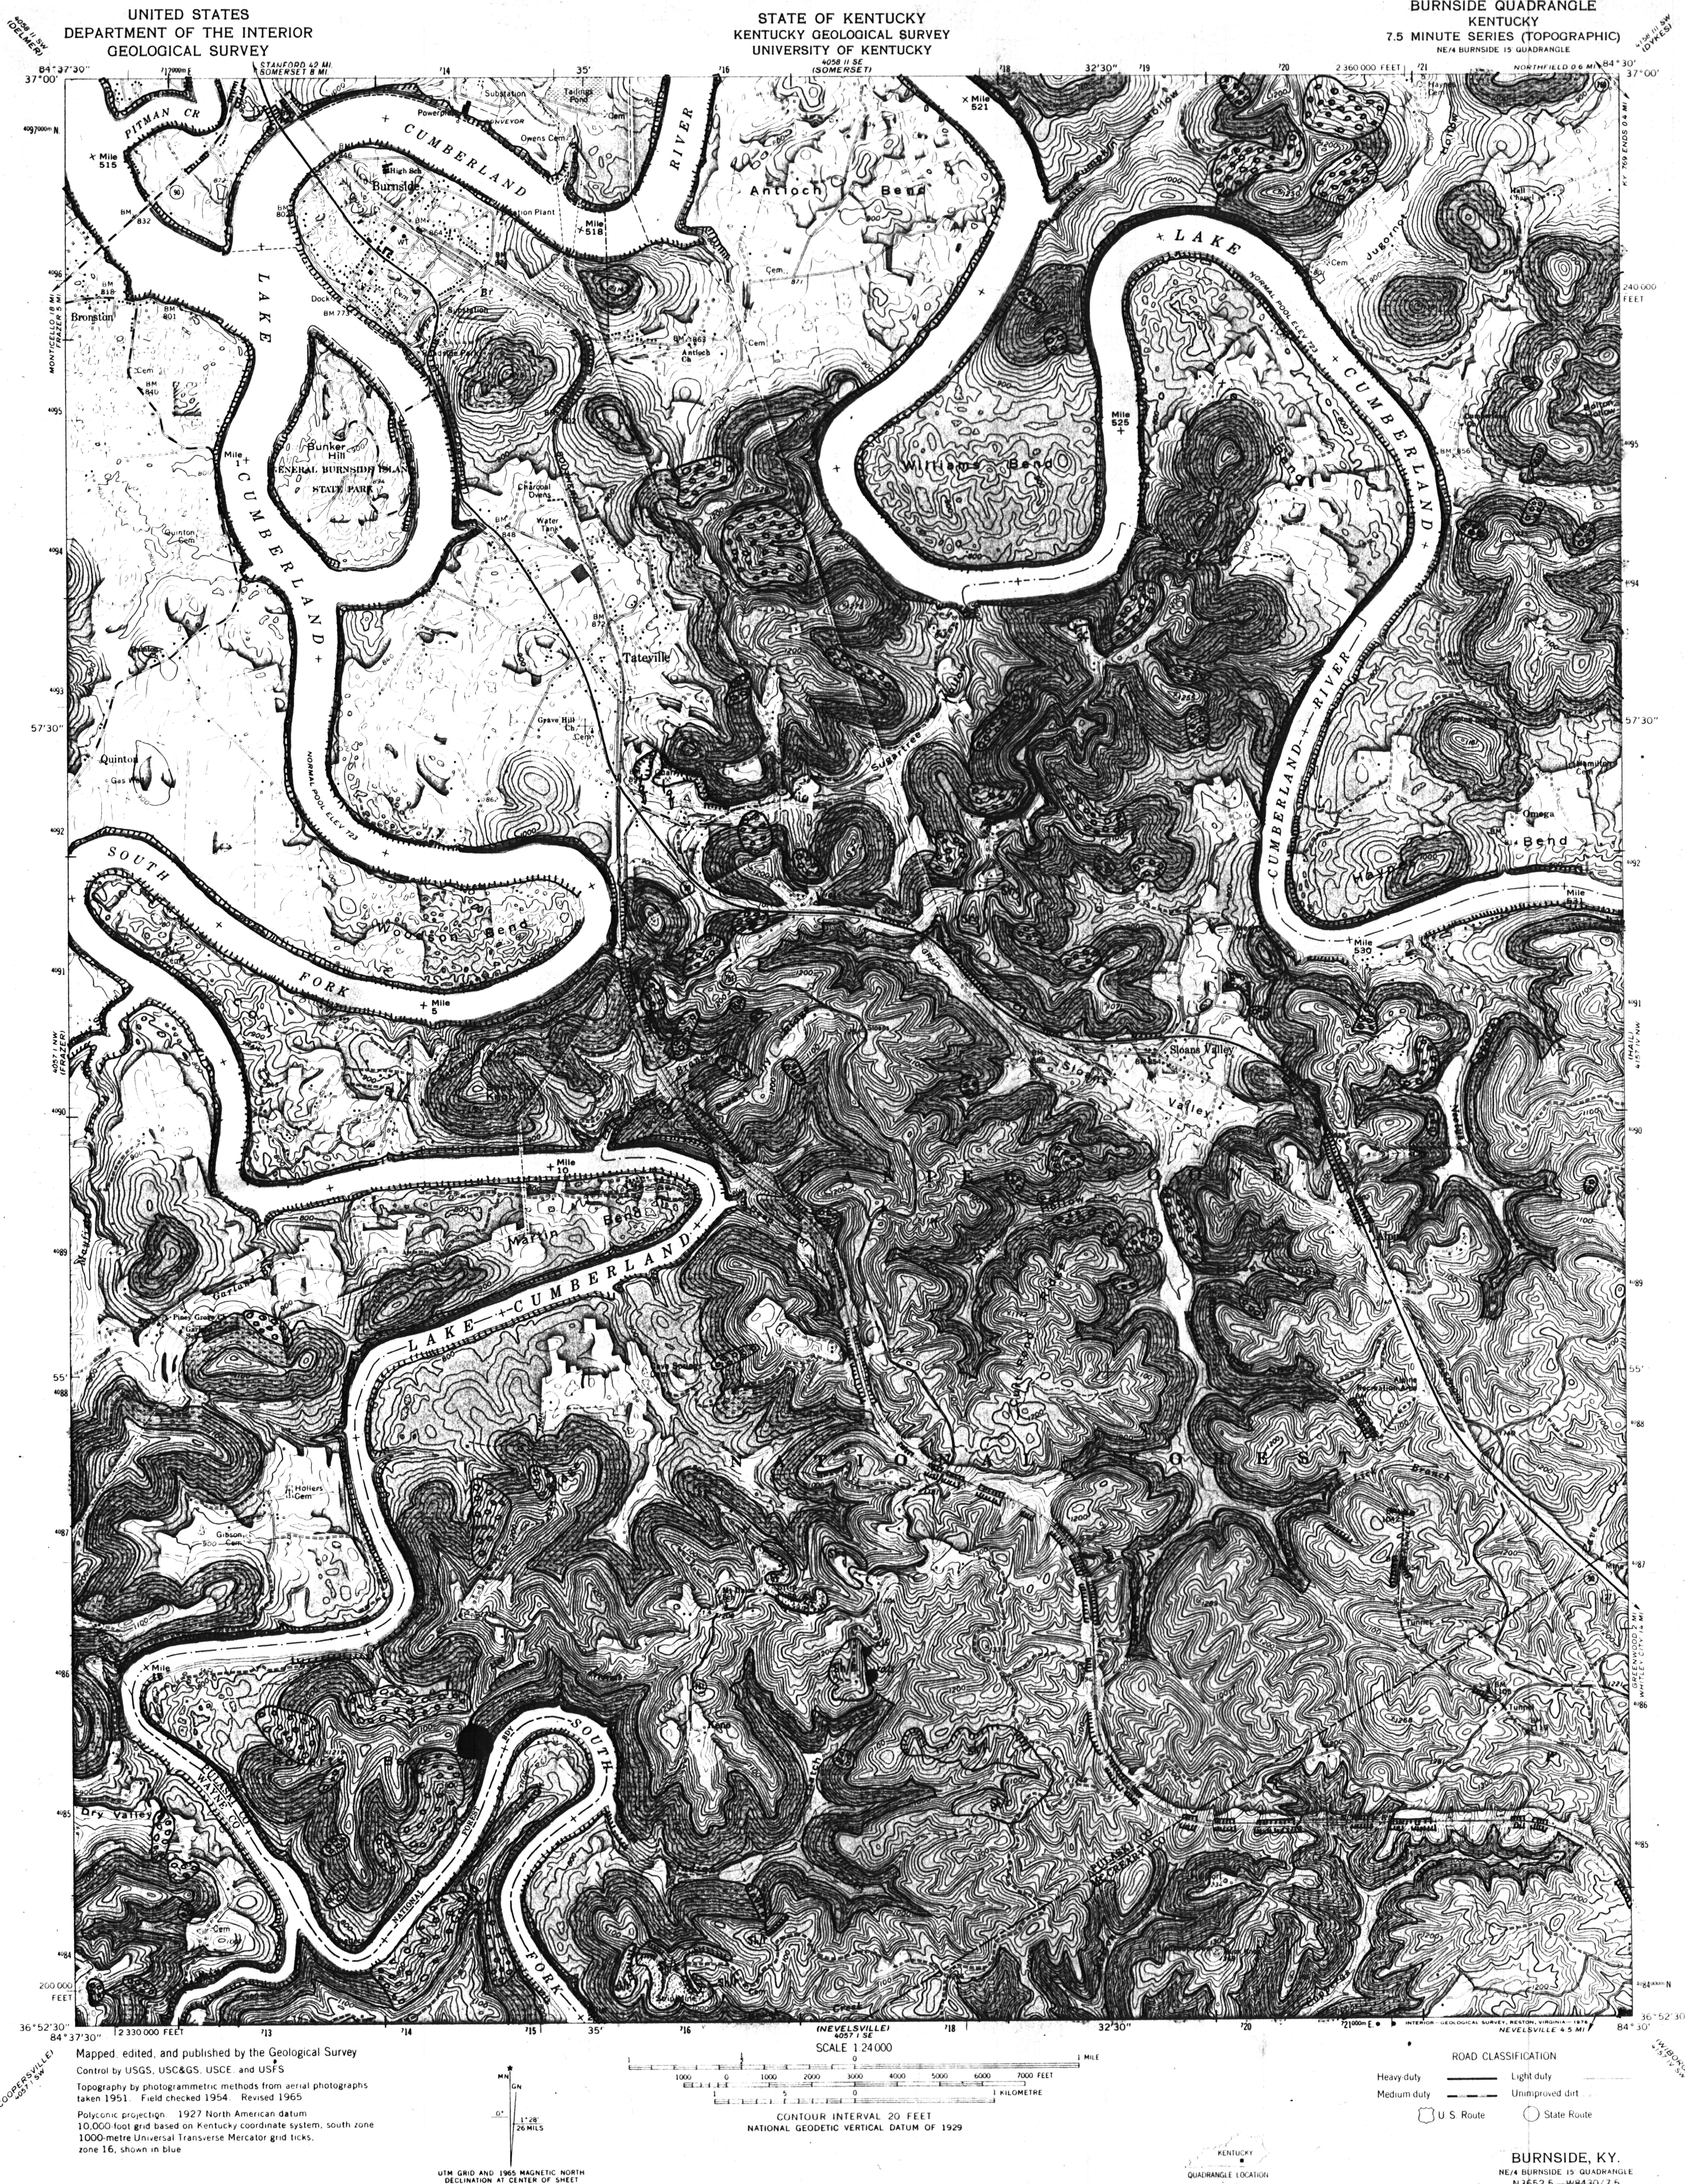
Landslides and related features interpreted from aerial photographs:
1:80,000 (Black and White) 1975
1:40,000 (Black and White) 1973

Photointerpretation and field check 1979-1980
This report is preliminary and has not been reviewed for conformity with U.S. Geological Survey editorial standards.

ACTIVE OR RECENTLY ACTIVE LANDSLIDE
Complex landslide composed of earthflow, debris slide, earth and rock slump. Identified from historical records, and from scars, debris and other field evidence. Ground extremely unstable; sliding accelerated by excavation, loading and changes in drainage conditions. May include areas with several active slides too small to be shown separately. Questioned where doubtful.

OLD LANDSLIDE
Area of extensive hummocky ground caused by earthflow and earth and rock slump. Lacks clear evidence of active sliding. Relatively stable in natural, undisturbed state, generally not affected by small structures properly sited in areas away from the edge of the toe; can be reactivated by extensive, rapid excavation, loading, and changes in ground water and surface water conditions. Area of old landslide probably includes recent ones not identified from field evidence or otherwise documented. Upslope boundary of landslide generally defined by modified scarp, but downslope (toe) may be gradational and not well defined. Questioned where doubtful.

COMBINATION LANDSLIDE
Area of recent and old slides in which individual slides are not identified.

COLLUVIAL SLOPE
Valley wall along major streams with slope as steep as 40° (85%); stony, clayey silt soil up to 50 ft. (15 m) thick; commonly buttressed by a terrace or bench at the toe of the slope; very susceptible to sliding by cutting of toe area, removal of terrace or bench, and overloading; slide commonly activated without apparent cause.

COLLUVIAL SLOPES WITH LANDSLIDES
Landslides too small or obscure to map individually.

AREAS SUSCEPTIBLE TO DEBRIS FLOWS AND DEBRIS AVALANCHES
Primarily shallow, narrow ravines and chutes with accumulation of stony colluvium generally 10 ft. (3 m) or less in thickness; susceptible to rapid movement during intense rainfall. Most ravines and chutes designated show evidence of former debris flows and avalanches.

AREAS SUSCEPTIBLE TO ROCKFALL
Steep, locally vertical, natural and man-made slopes and cliffs, 15 ft. (4.5 m) or more high; formed dominantly of sandstone, limestone, sandy shale, mudstone and claystone. Interbedded mudstone, claystone and shale weather rapidly leaving sandstone and limestone rock faces unsupported.

SOIL AND ROCK SUSCEPTIBLE TO LANDSLIDING
Soil and rock similar to that involved in landslides elsewhere in map area; primarily areas underlain by claystone, mudstone and shale associated with other rock types. Rock weathers rapidly on exposure forming clayey soil highly susceptible to sliding. Includes coves (U-shaped, shallow valleys) containing thick layers of clayey soil that are very susceptible to sliding where excavation breaks continuity of slope and where overloaded by artificial fill.

AREAS LEAST PRONE TO LANDSLIDES
Map areas in which no patterns or symbols are shown; primarily valley floors, ridge tops and broad benches; modification by excavation and fill may lead to local landslides.
